MINERAL MATERIALS (CFR 3600)  
COMPLIANCE INSPECTION REPORT

INSPECTION DATE: September 6, 2013  
INSPECTOR: Duane Bays  
CASE NAME: Black Rock Quarry Negotiated Sale  
SERIAL NUMBER: UTU-088731  
APPLICATION TYPE: 361113  
COMMODITY DESCRIPTION: Limestone  
TOTAL DISTURBANCE ACREAGE: 4 acres  
ACTIVITY SINCE LAST INSPECTION: Extensive Reclamation Activity – Earthwork Complete  
CALCULATED VOLUME REMOVED: Not Determined

UTU-88731  
Fillmore Field Office

Allroc/Black Rock Negotiated Sale  
(Refer also to previous Plan of Operations UTU-79872)

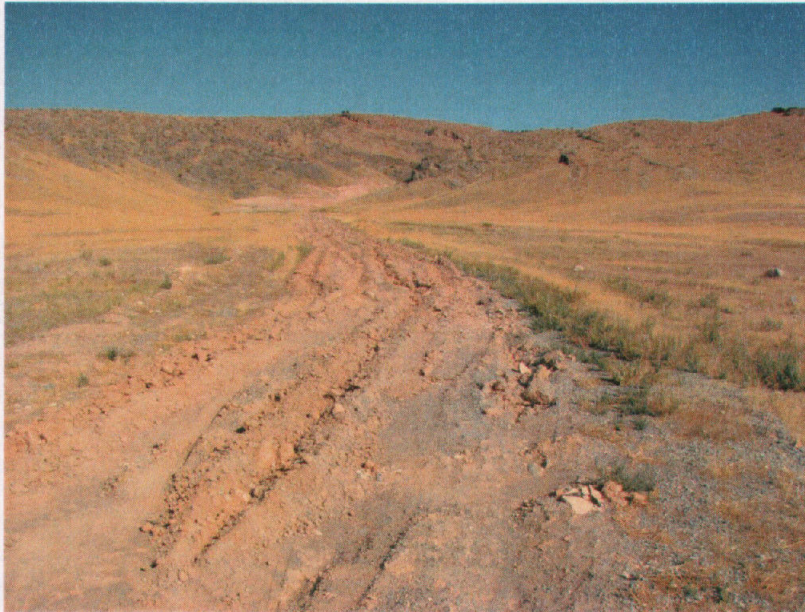
Photo 1. The operator has removed the trash pile from near the access road entrance. The road has been ripped and awaits reseeding later in fall 2013.

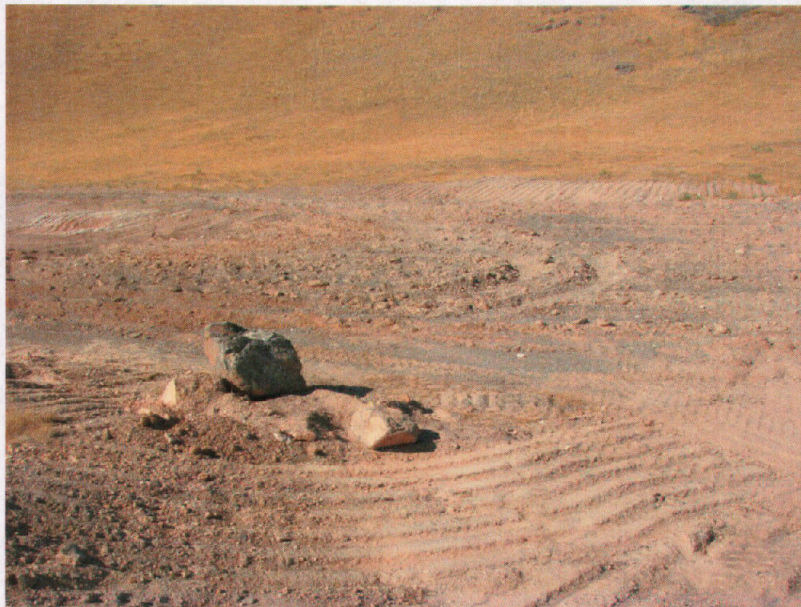
Photo 2. The earthwork on the surface disturbance areas is generally very good. Scarification of the surfaces will aid in the establishment of self-sustaining communities of mature native vegetation.

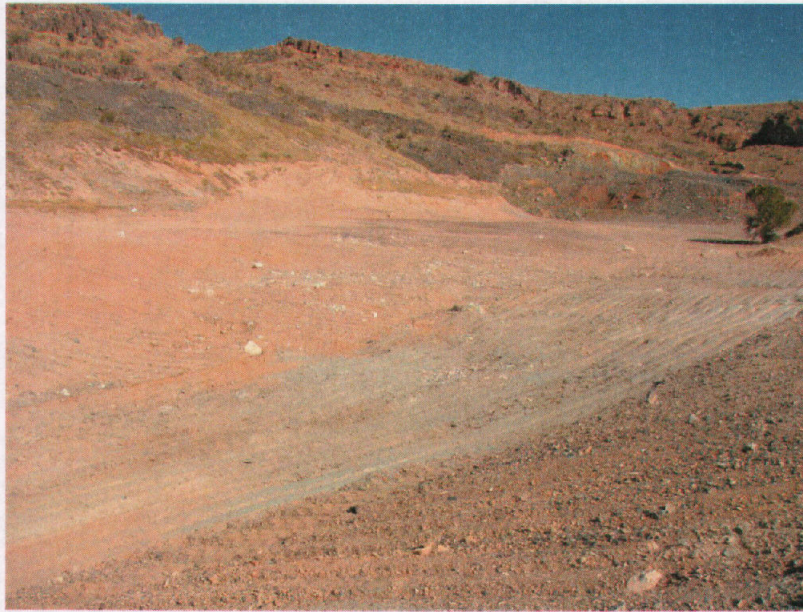
Photo 3. The current operator has done an excellent job of removal of trash from the former operator. The current operator made a point of removing artifacts whenever possible rather than burying them. The excellent earthwork has eliminated much of the topographic discontinuity from the earlier operator.

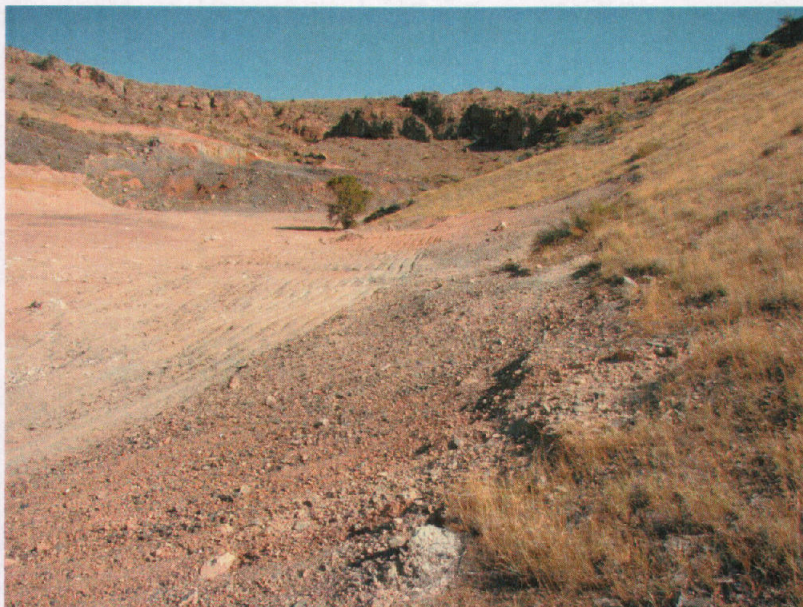
Photo 4. The former escarpments along the edges of the site have been appropriately sloped. The former access road loop through the site has been obliterated.

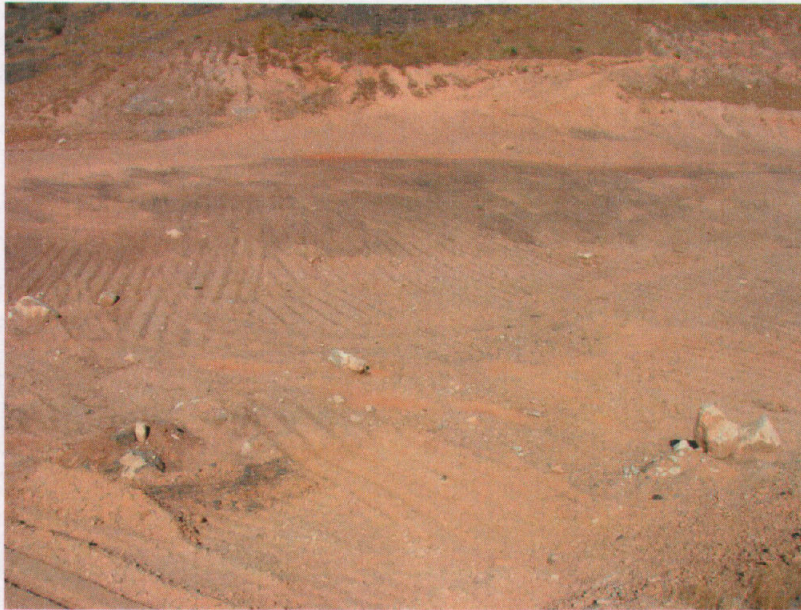
Photo 5. The central part of the site has been leveled and scarified. This view faces southwestward from the edge of the surface disturbance area.

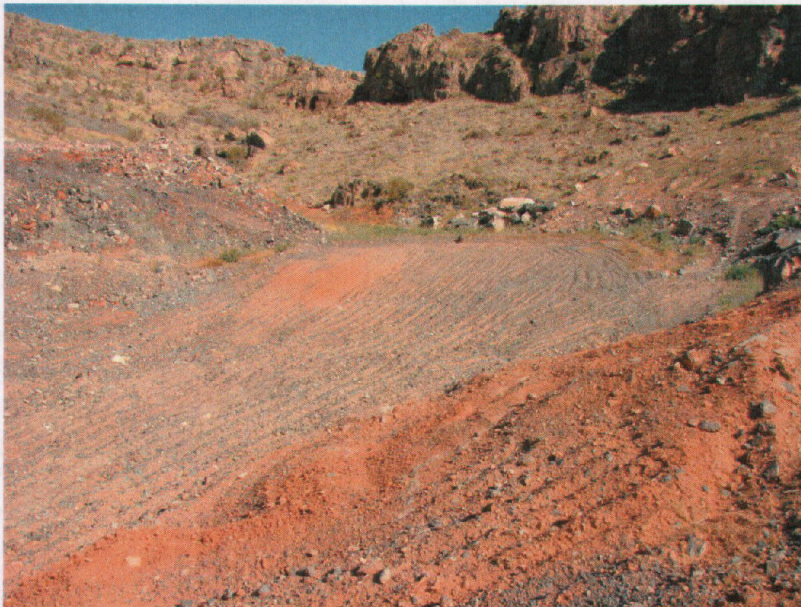
Photo 6. This view of the upper part of the area shows the considerable efforts of the operator to perform good earthwork. The rockpile at the left edge of the photo was left due to safety concerns about heavy equipment operation on the steep slope of loose rock.

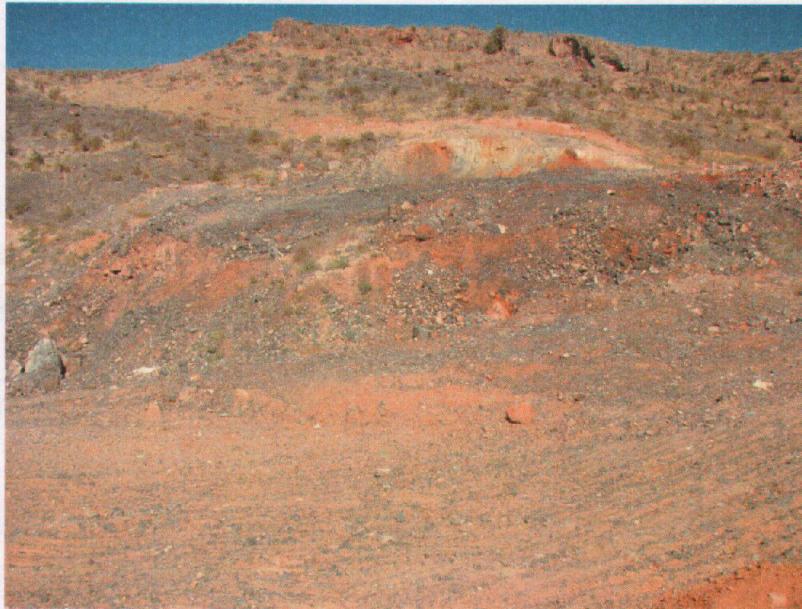
Photo 7. This photo shows the hillside area of loose rock and an uphill legacy road cut. The road cut pre-dated recent operations and was left due to safety concerns about operations on the steep slope.

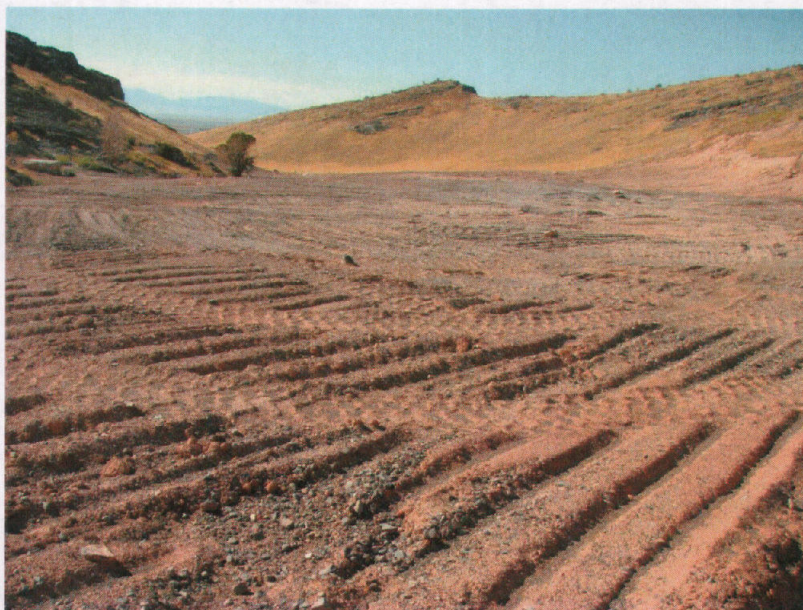
Photo 8. This southeastward view faces across the central part of the site toward the former entrance. Scarification of the surface will accelerate the rate of revegetation.

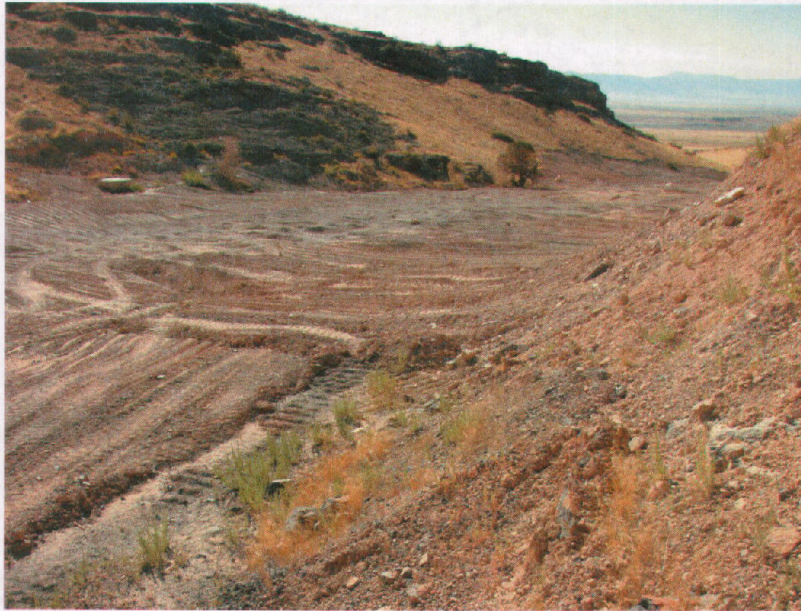
Photo 9. This photo shows the natural hillside slope grading rather seamlessly into the slope of the earthwork on the lower section of the gradient. The black material on the opposite side of the surface disturbance area is intact carbonate rock.

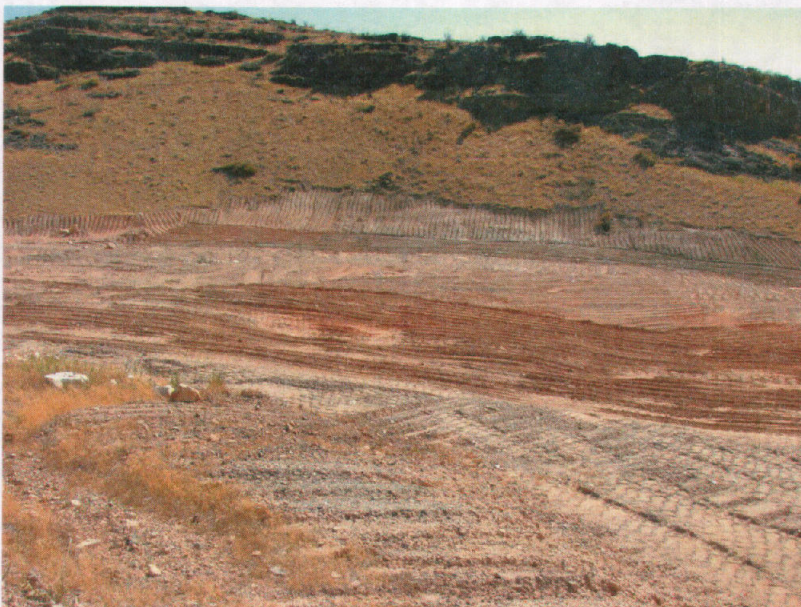
Photo 10. The earthwork along the slopes is very good in most places. This view faces northeastward. Satisfactory revegetation is the only task remaining at this location.

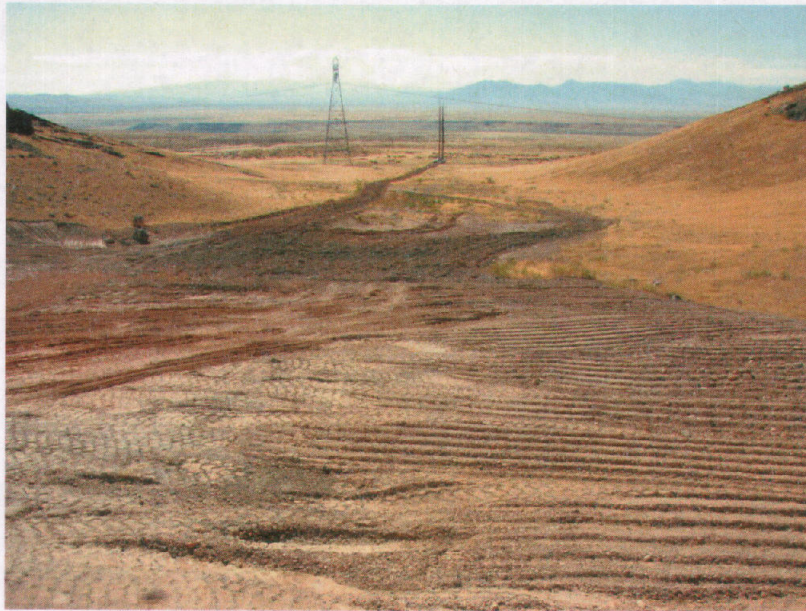
Photo 11. This view toward the entrance to the site shows the ripping of the former access road and other areas near the entrance. Antelope Mountain is visible in the distance.
